BLUFF AND BEACH FAILURES

ROCK BLUFF FAILURES

INFRASTRUCTURE FAILURES

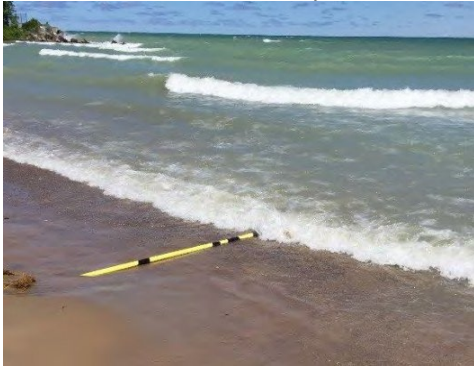
Exposed Infrastructure

An old pipe that has been exposed by beach erosion.
Photo: Ethan Theuerkauf

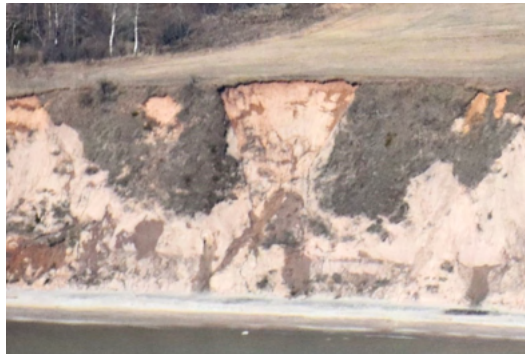
Loss of Vegetation

A sandy bluff has some remaining vegetation mats securing the slope surface. Photo: Wisconsin Shoreline Inventory and Oblique Photo Viewer.

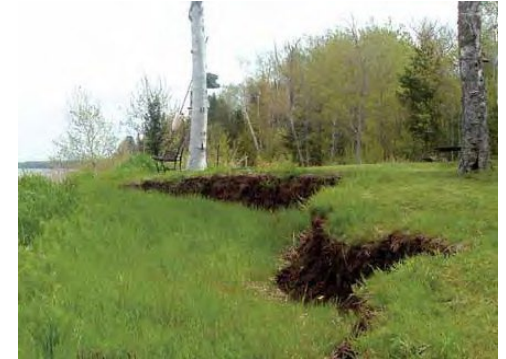
Ground Cracks

Horizontal ground cracks at the top of the bluff that preceded a slope failure. Photo: Gene Clark

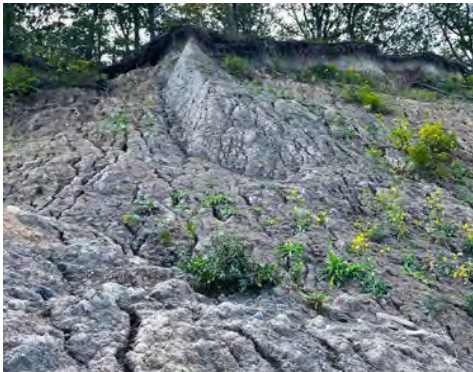
Surface Water Drainage Rills or Gullies

Rills on a bluff face caused by surface water drainage down the slope. Photo: Hannah Paulson

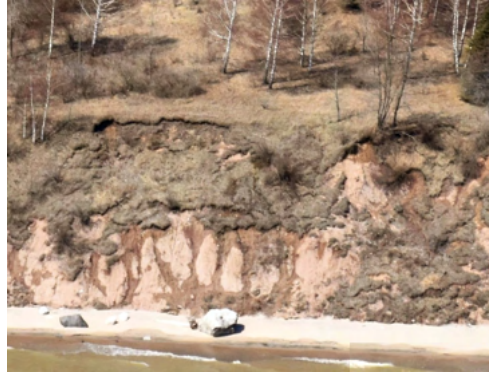
Groundwater Seepage

Evidence of groundwater draining through slope of bluff face. Photo: Wisconsin Shoreline Inventory and Oblique Photo Viewer

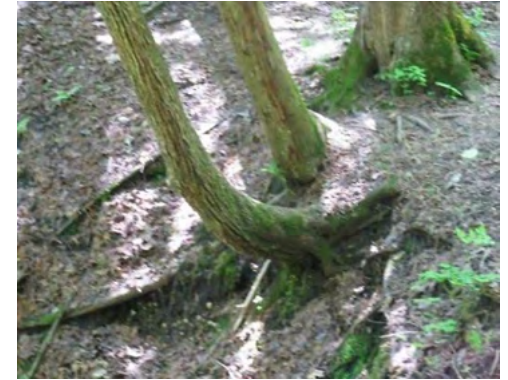
Curved Vegetation

Trees with curved trunks that are concave in the upslope direction. Photo: Adam Bechle

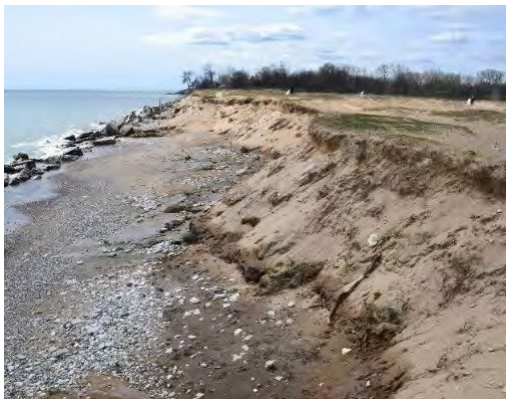
Toe Erosion (Bank)

Toe Erosion on a sandy bank. Photo: Adam Bechle

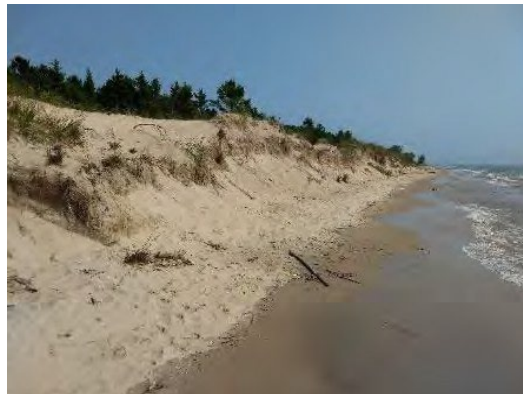
Toe Erosion (Dune)

Toe erosion on a dune marked by loss of vegetation. Photo: Adam Bechle

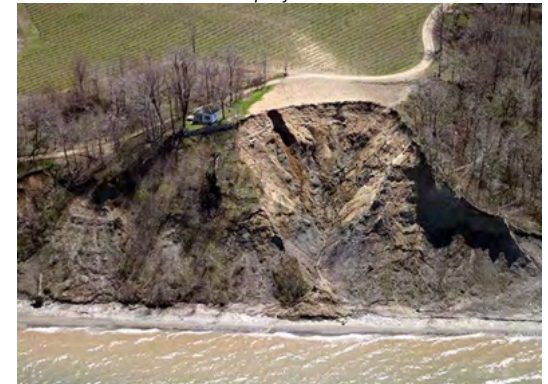
Slides or Slumps

A deep slump in sandy, mixed material bluff. Photo: PA Dept of Env Protection

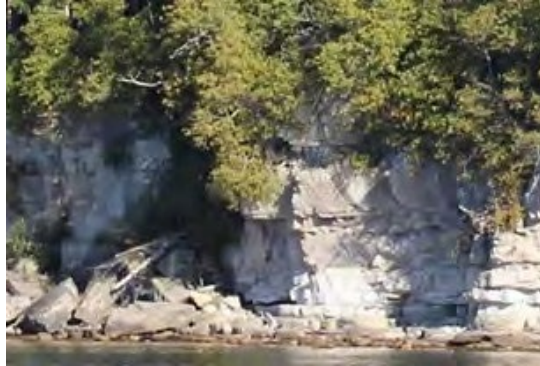
Overhanging Vegetation

Overhanging and fallen trees and cracks in the rock face show evidence of failure on the bluff top.
Photo: Anne Iwata, Wisconsin Coastal

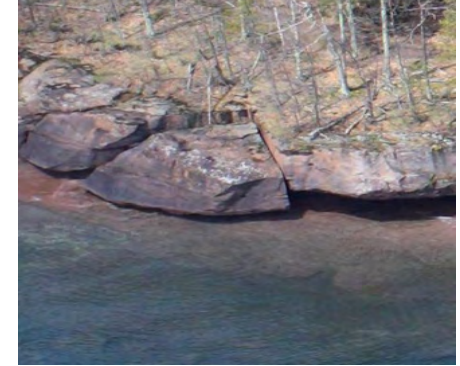
Structural Crack

Major cracks indicate a weak point in the rock bluff.
Photo: Wisconsin Shoreline Inventory and Oblique Photo Viewer

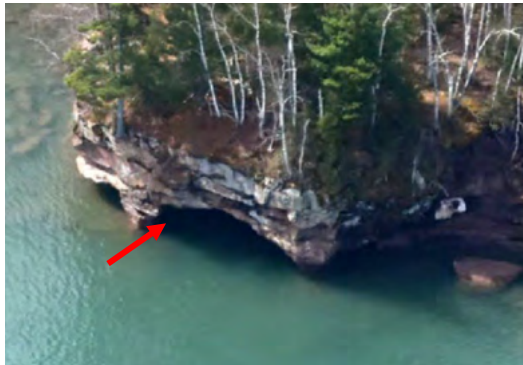
Toe Undercutting

The toe of this bluff is starting to be undercut leaving an unsupported overhang.
Photo: Wisconsin Shoreline Inventory and Oblique Photo Viewer.

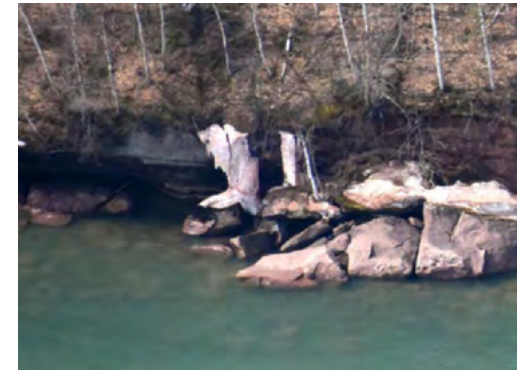
Freeze/Thaw Cycles

Water percolates into cracks, freezes, and expands creating instability.
Photo: Wisconsin Shoreline Inventory and Oblique Photo Viewer.

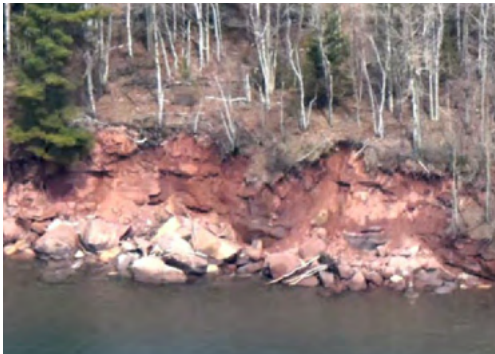
Groundwater Seepage

Darkened areas in the clay cap over the bedrock bluff can indicate slope stability issues.
Photo: Wisconsin Shoreline Inventory and Oblique Photo Viewer.

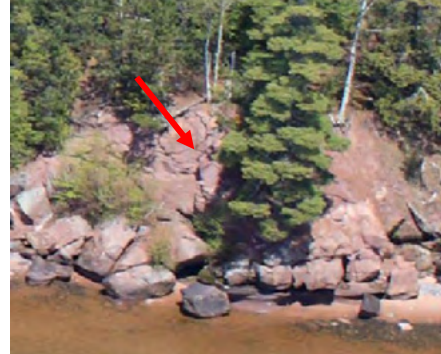
Deep Cracks

Major cracks spanning height of the rock face can indicate an imminent failure.
Photo: Wisconsin Shoreline Inventory and Oblique Photo Viewer

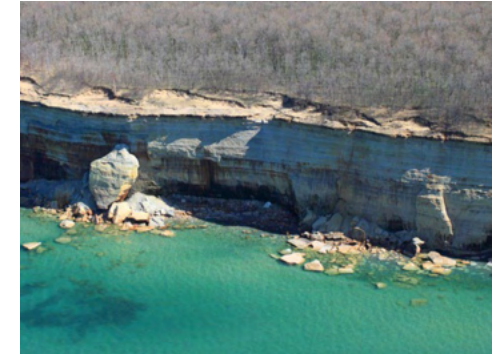
Rockslide

Large fallen rock debris shows evidence of a rock slide.
Photo: Michigan Tech, EGLE

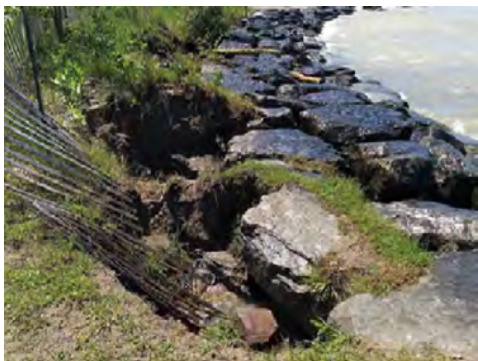
Wave Overtopping

Overtopping of this revetment has led to erosion on the back side of the armor stone. Photo: Adam Bechle

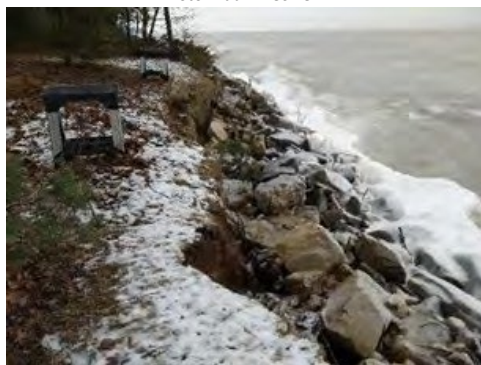
Revetment Settling

Revetment stone has slid lakeward lowering the crest height. Photo: Adam Bechle

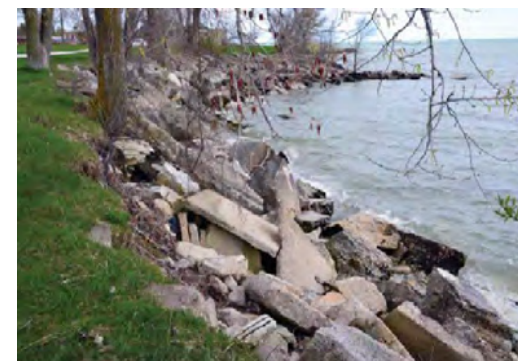
Unsuitable Materials

Flat pieces of concrete rubble do not interlock well and may be easily moved by strong waves. Photo: Adam Bechle

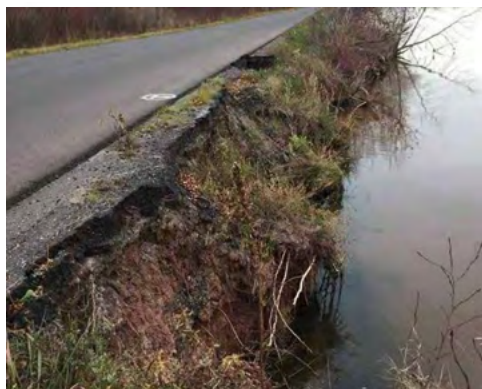
Roadway Washout

A road along Lake Superior is near failure from erosion. Photo: Rob Peterson

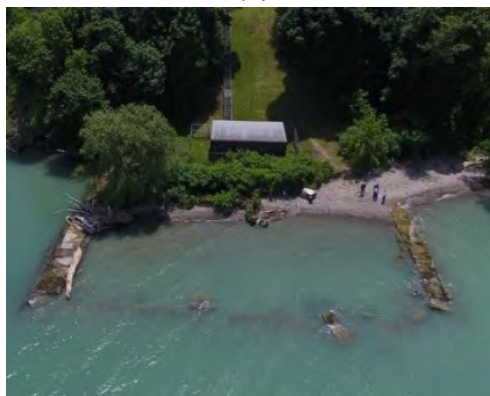
Breakwall washout

Breakwall flooding during high water levels. Photo: City of Conneaut

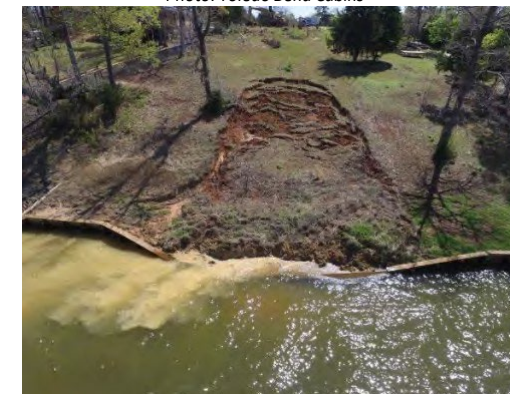
Overtopping resulting in a slide

High water overtopped this sea wall triggering an erosion slide. Photo: Toledo Bend Cabins

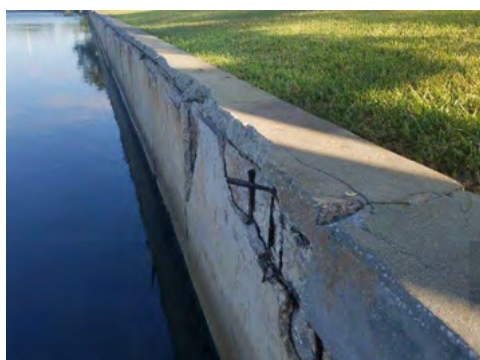
Cracked Seawall

Cracks and separations in the concrete cap of this sea wall. Photo: Biller Reinhart Engineering

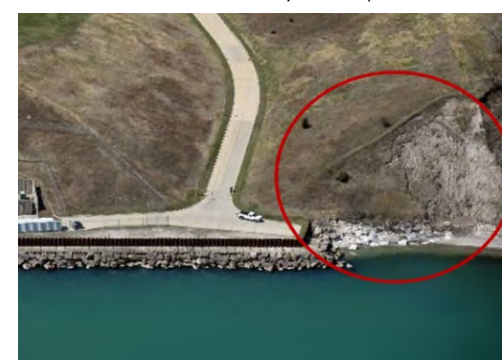
Flanking

The Oak Creek Water Intake Structure with erosion flanking (redcircle). Photo: Wisconsin Shoreline Inventory and Oblique Photo Viewer
